RUSSEL SANDIFER DAM

MARION COUNTY, MISSOURI

MO 10259

PHASE I INSPECTION REPORT  
NATIONAL DAM SAFETY PROGRAM.

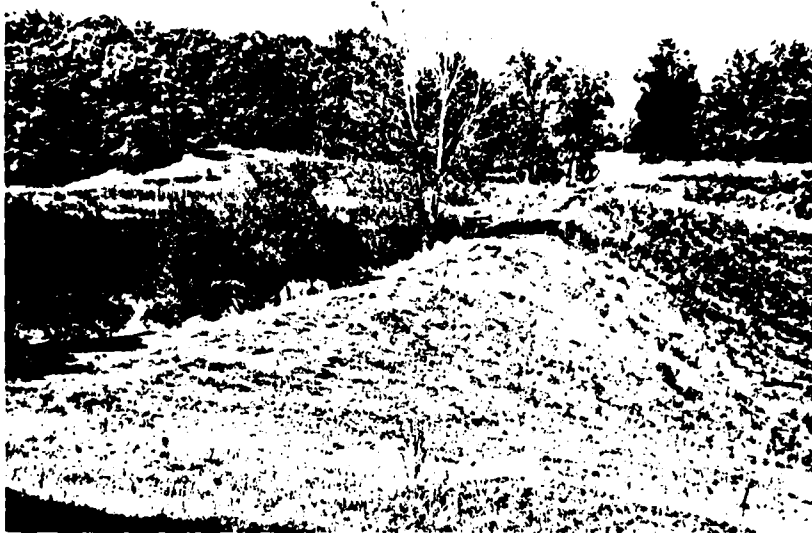
Photo 1 - View along crest of dam taken at right abutment.

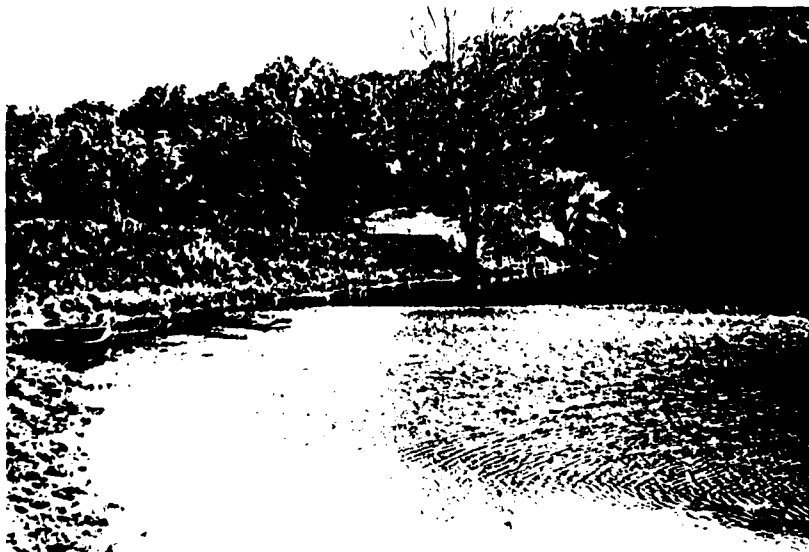
Photo 2 - View of upstream slope of embankment taken at left abutment.

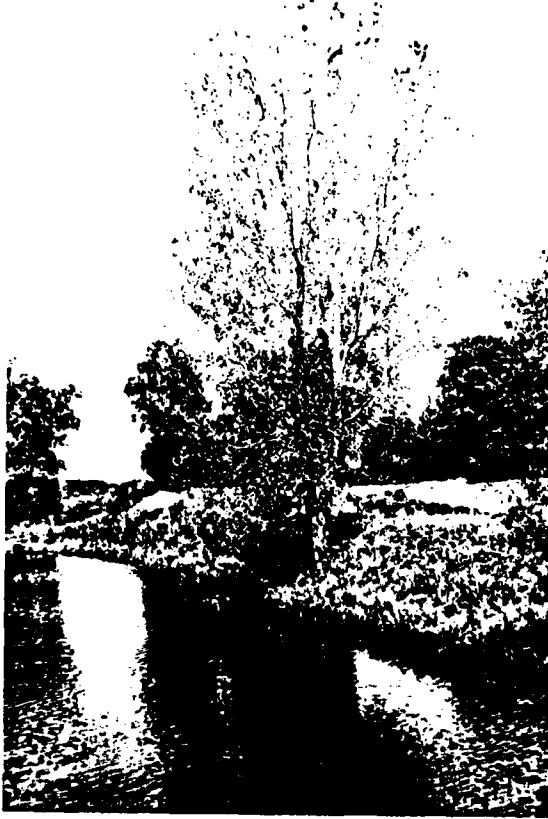
Photo 3 - Picture of upstream embankment slope taken at right abutment.

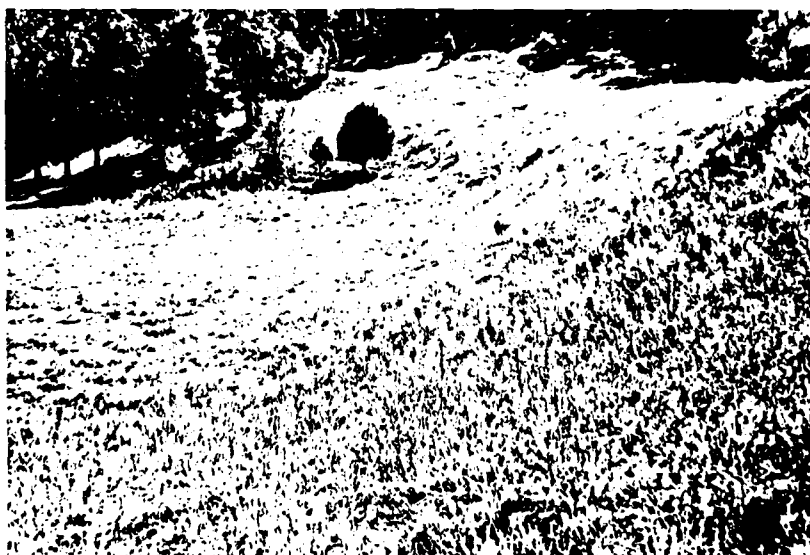
A spring was noted about 30 feet east of the downstream toe, and at the base of the ridge on the right side of the dam. We understand this spring existed prior to construction of the dam, and has not enlarged since impoundment of the reservoir water.

Photo 6 - View of downstream embankment slope taken at left abutment. Note location of spring at top and left of picture.

The spring located downstream of the dam on the right side should be monitored for changes in quantity, location or color of the water. It is not felt that the spring poses a problem with the stability of the embankment, but monitoring will enable rapid identification of changes which may indicate a hazard.

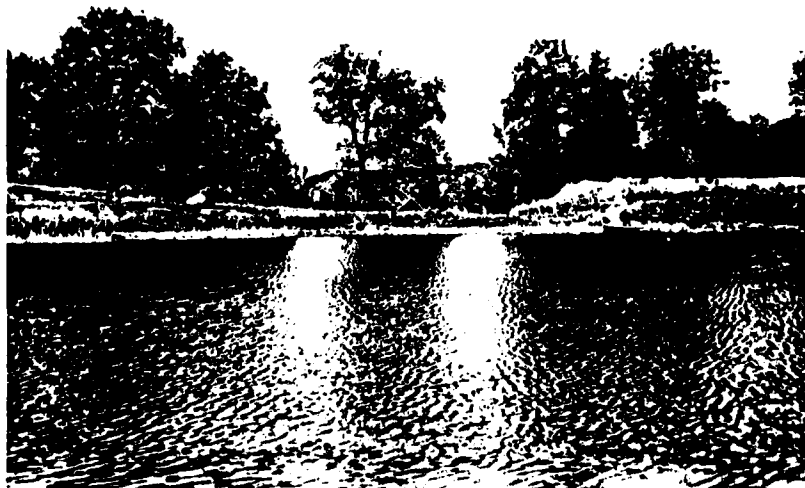
Photo 8 - Picture of service spillway pipe and emergency spillway channel.

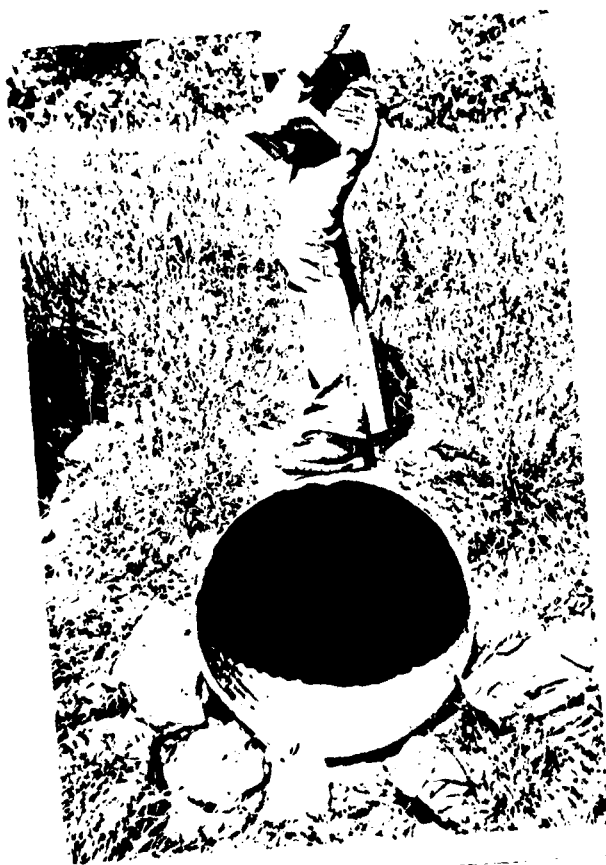
No seepage was visible in the area of the service spillway discharge pipe. The C.M.P. discharge pipe appears in good condition. However, there is no trashrack at the pipe inlet, nor energy dissipator at the exit. The service spillway releases water into the adjacent drainage basin, and would not affect the safety of the dam. The emergency spillway is in fairly good condition, with the exception of areas of minor sloughing which were noted on the left slope immediately downstream from the spillway crest. Flow through the spillway would be dissipated at the downstream valley plain, and would not pose danger to the structural integrity of the dam.

Photo 10 - Close-up of 24-inch I.D. corrugated metal pipe for service spillway.

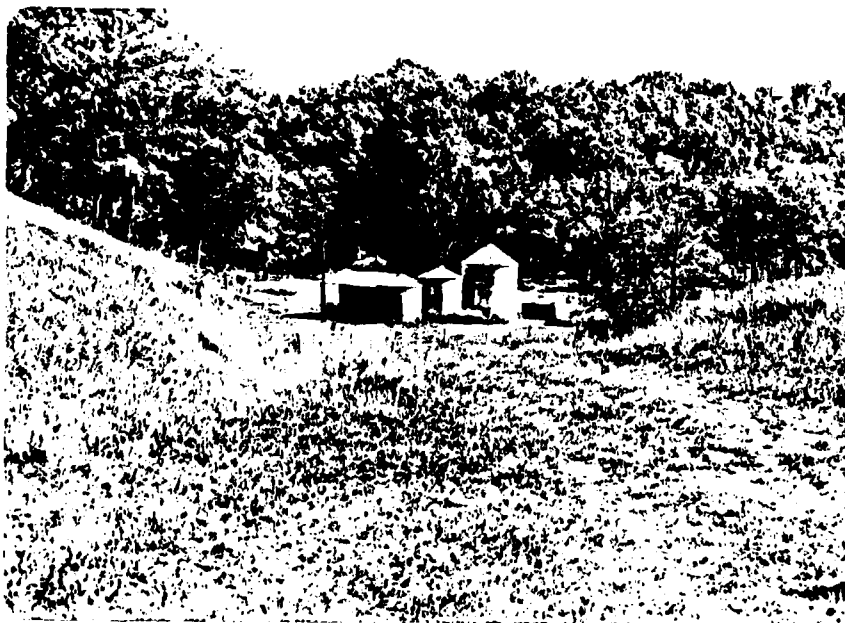
Photo 12 - View of emergency spillway discharge channel taken at spillway crest.
